Other Products

RB Valves

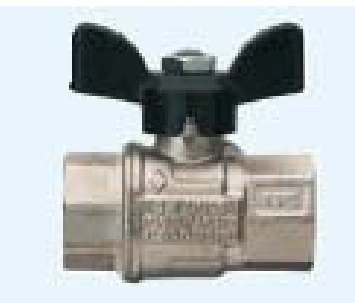
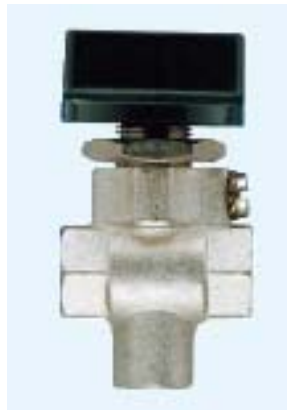
We stock a wide range of valves from 1/8" to 3" ports in both 2-way and 3-way designs.

Actuation is by T-handle or lever plus on the larger sizes there is an ISO pad so that they can be fitted with a pneumatic rotary actuator.

Most of the valves have nickel plated brass bodies with a PTFE seat and are rated from -20°C to +130°C.

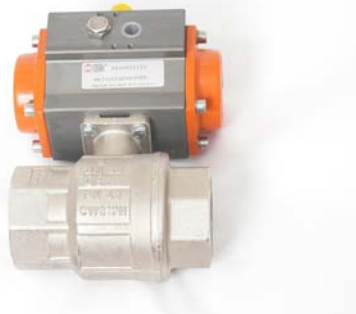
Rotary actuators are available in both single and double acting to operate the CEME ball valves. The body of the actuator can be in aluminium (painted), chemically nickelled aluminium or technopolymer depending on the application. We also make ISO pad adaptors so that a smaller sized actuator can be fitted to a valve if it is only being used at low pressure, for example on water tankers.
